Collision Reconstruction Report

Sara Echevarria vs. U-Haul Company

Delaware State Route 2 near the Intersection of Upper Pike
Creek Road

Date of Report: October 20, 2006

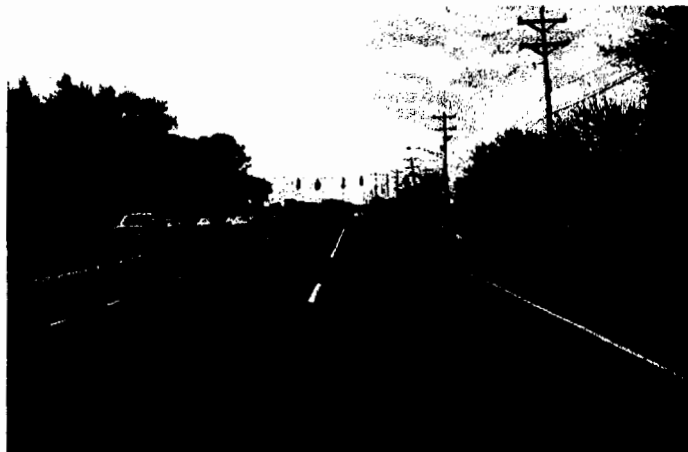
- 1. State Route 2, at the collision location near the intersection of Pike Creek Road, was a properly divided six-lane roadway that traveled in a west/east direction. The roadway had the proper lane delineations and transverse markings for the travel lanes as seen in photograph #1.

**Photograph #1: State Route 2 at the collision location near
Pike Creek Road
(Writer's Photograph)**

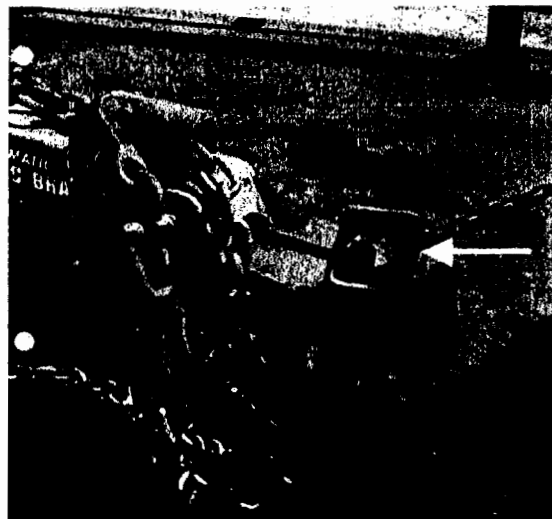
The majority of the damage to the 12-foot U-Haul trailer was located at the front tongue, which struck and penetrated the side of V¹ resulting in its rollover onto the roadway. The trailer's associated frontal view and tongue damage can be seen in photographs #2 and #3.

Photograph #3: Tongue Damage to the 12-foot U-Haul Trailer (Case File Photograph)

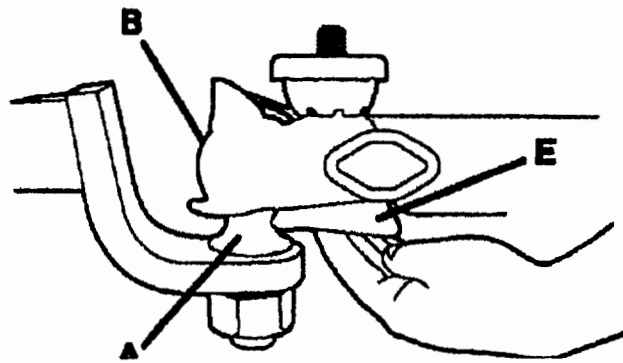
Figure 1: U-Haul Coupler

The tongue attachment to the hitch consisted of a latch clip and a hand wheel assembly. By turning the hand wheel assembly clockwise, it tightens the tongue to the 2-inch tow ball attached to the hitch. If the hand wheel is damaged or malfunctions, the trailer will not be properly attached and will become detached during the normal driving operation of the trailer.

During the routine six point inspection conducted by U-Haul prior to rental of this unit to Mr. Mayfield, the components of the trailer's coupler were not properly inspected nor was Mr. Mayfield given the proper instructions regarding the attachment and proper use of the trailer during his cross country towing of this trailer.

If U-Haul had completed a thorough inspection, they would have detected a problem with the trailer's hand wheel thus preventing the detachment of the trailer from the truck.
